A novel mooring tether for highly-dynamic offshore applications: Durability in the marine environment

T Gordelier, L Johanning, P Thies, D Parish.

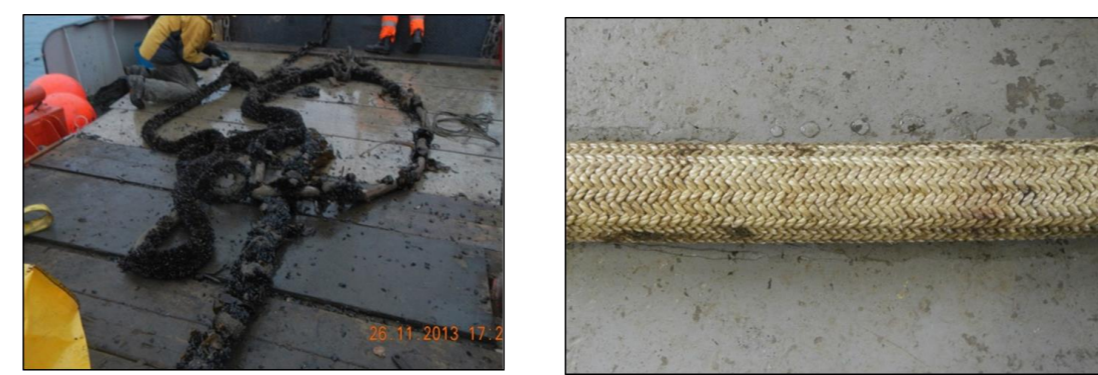
Significant marine growth developed during the deployment but after cleaning with a brush and fresh water there was no external evidence of fretting.

Figures 4 & 5: Marine growth on Tether P1-8. Before (L) and after (R) cleaning

- A jacket should be developed to protect the Exeter Tether from marine biofouling as debris from this may cause long term damage to the Tether components.

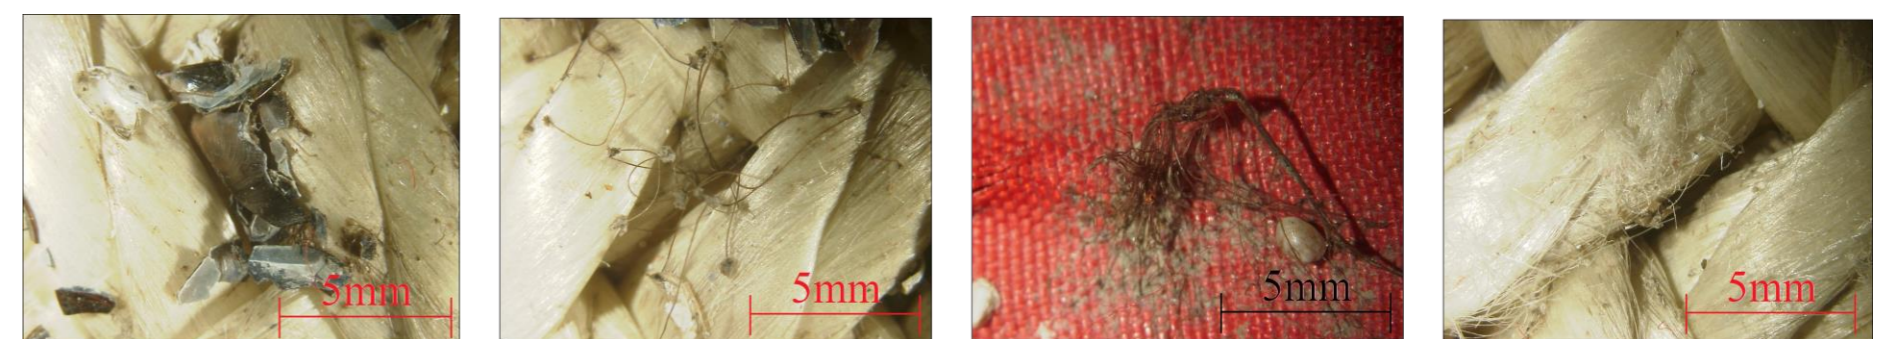
On opening up the tether for review, marine growth had penetrated all parts of the tether and the beginning of rope filament damage was evident due to this.

Figures 6 – 9: Mussel growth; byssal filaments on rope; byssal filaments on screen; rope filament damage.

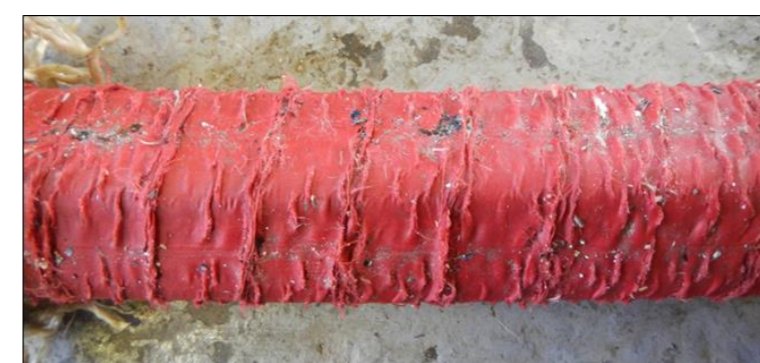
The anti friction membrane showed signs of degradation, with pressure tears and areas of wear evident.

Figure 10: Anti-friction screen showing evidence of pressure tears and wear. Bio-fouling debris is also viable.

- Alternative materials should be trialled for the anti-friction screen. Two alternative membranes have recently undergone extensive testing at the DMAc Test Facility.
