A novel mooring tether for highly-dynamic offshore applications: Durability in the marine environment

T Gordelier, L Johanning, P Thies, D Parish.

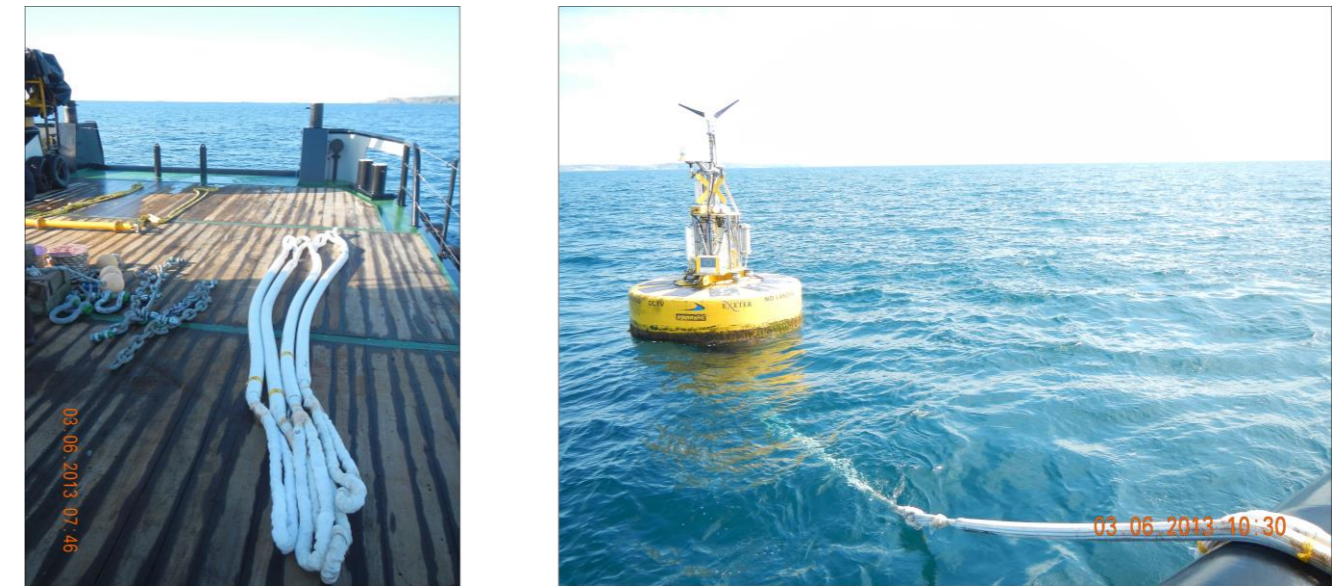
Four different tether prototypes were deployed on a limb of the South West Mooring Test Facility (SWMTF) from the 3rd June 2013 to 26th November 2013 to observe the affect of the marine environment on the different components of the tether.

Figures 2 & 3: Four tether prototypes deployed at SWMTF

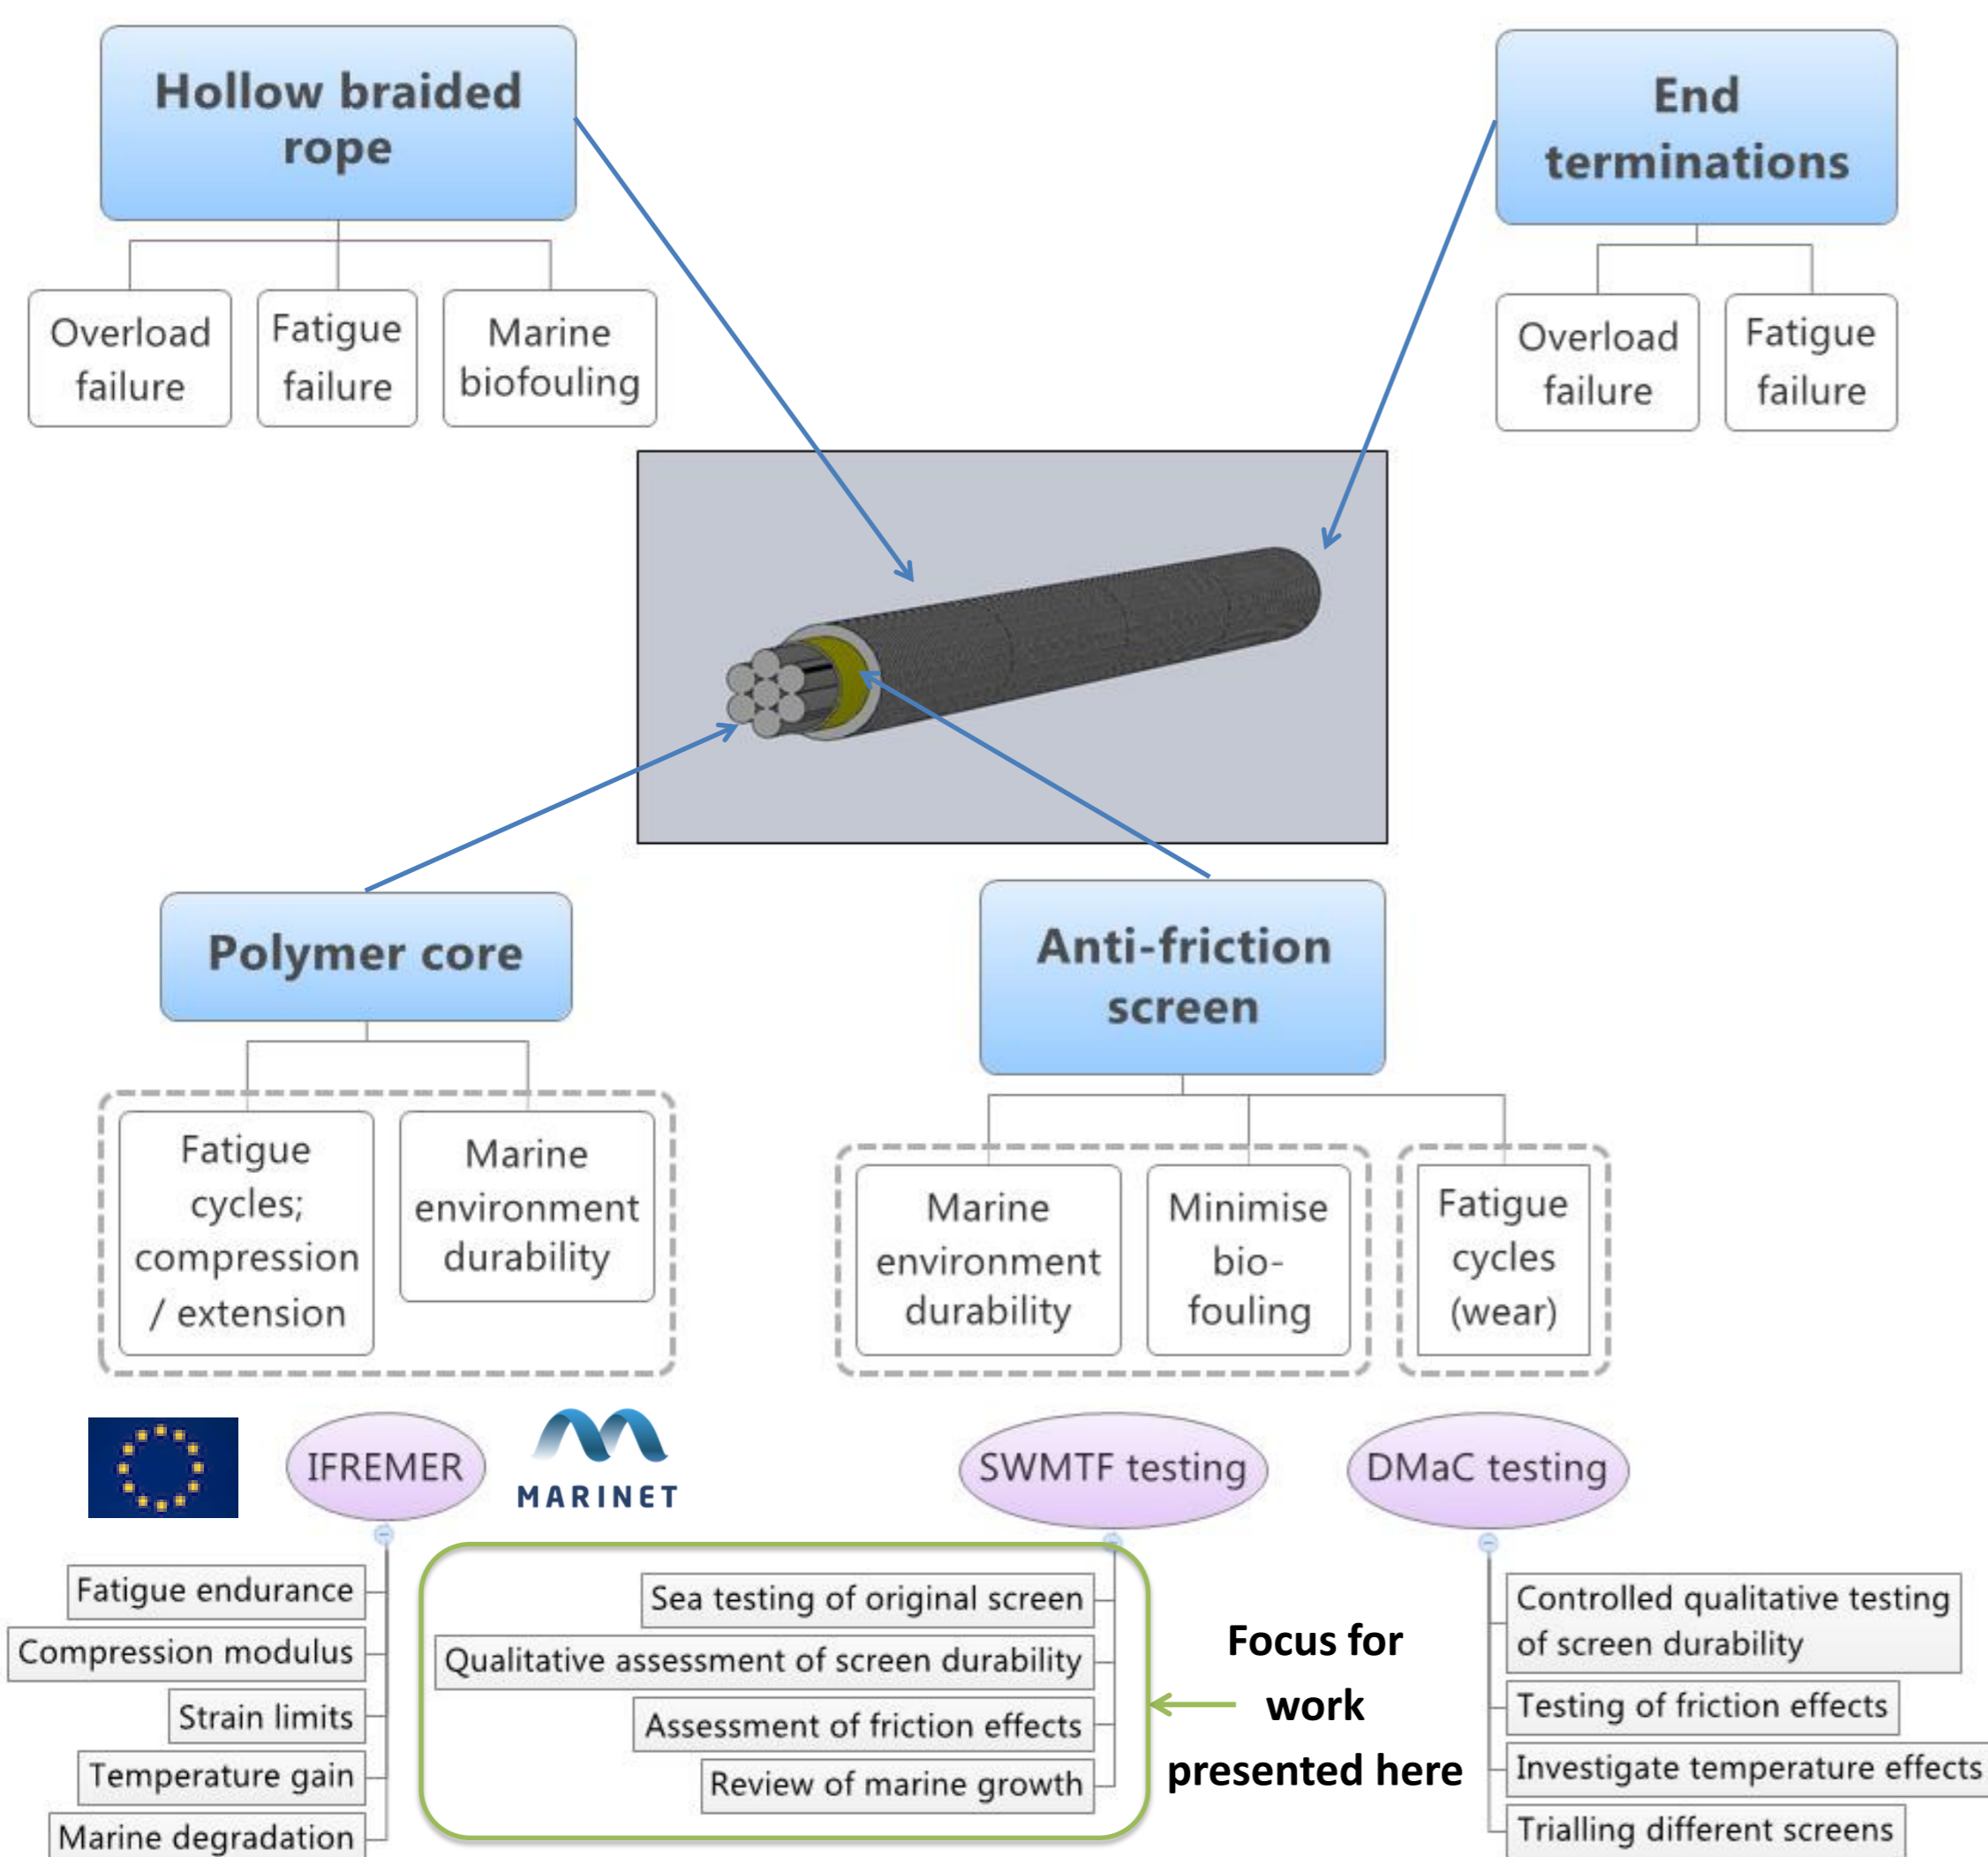
Figure 1: Key components and reliability considerations of tether, with research facilities and approaches detailed for selected components
